EMERGENCY OUTLET GATE REPLACEMENT PROJECTS AT TWO EL DORADO IRRIGATION DISTRICT HIGH SIERRA LAKES

William Rettberg, P.E. and Jacob E. Eymann, P.E.

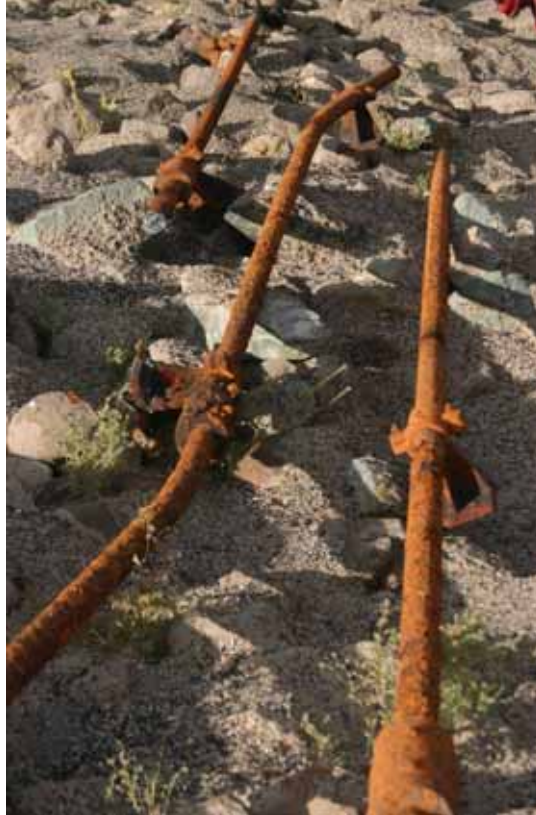
- Bronze seats for the lower slide gate were missing, resulting in excessive leakage and vibration;
- The lifting connection of the lower slide gate leaf and the gate stem was degraded and loose;
- The concrete adjacent to the lower slide gate frame was heavily eroded, resulting in steel reinforcement exposure and corrosion;
- The lower gate stem was bent in two directions, which resulted in binding against the concrete shaft wall and the upper gate during gate operation;
- Several metal stem restraints required to align, guide, and prevent stem buckling were missing or broken;

- The slide gates, gate stems, and stem guides were all severely corroded, compromising their structural integrity and putting them at risk of sudden failure;
- Both gate stems were found to be installed out of plumb;
- Combined leakage from the closed slide gates was approximately 900 gallons per minute and
- The trash rack on the intake was severely bent and dislodged from its original installation.

Figure 7. Section of 70 foot long Caples outlet valve stem after removal during 2008 emergency repair (notice permanent deformation).

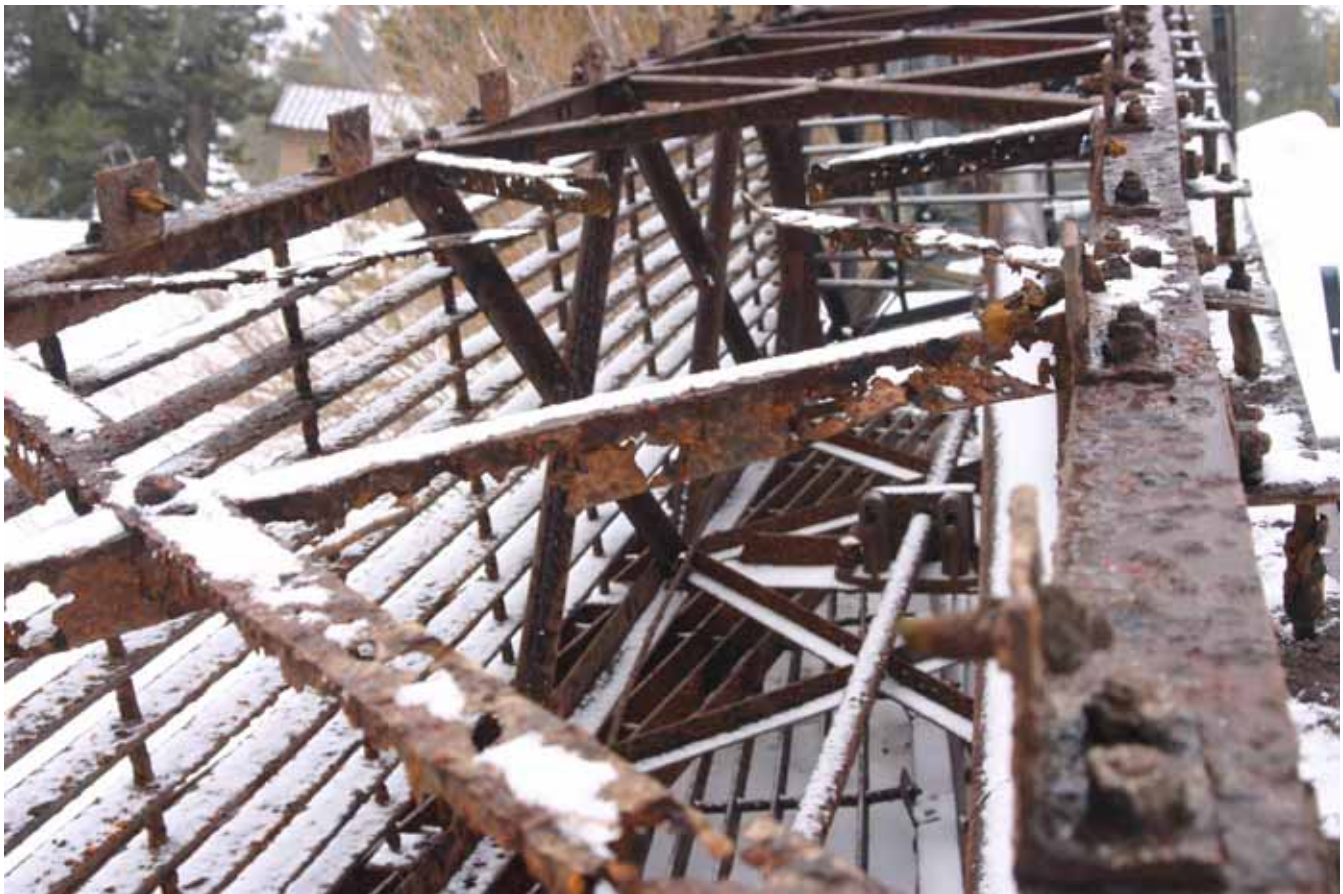
- The steel bracing for the outlet tower was completely failed due to corrosion;
- The other steel members had experienced significant corrosion and section loss;
- The degree of corrosion increased from top to bottom on the outlet tower;
- The valve stem was heavily corroded and pitted.

Figure 8. Silver Lake outlet tower removed during the 2008 emergency repair - Notice all of the missing sections of structural bracing leaving no bracing for the lower vertical third of the tower.

In the case of Silver Lake, the outlet tower is located near the crest of the dam in about 25 ft of water. Since the tower steel was heavily corroded, alternatives were limited to complete removal and replacement. Because this work was scheduled during the height of the winter, the decision to prefabricate the tower was necessary to speed erection time. Again, lack of reliable as-built drawings required assuming foundation conditions and how the new gate would be aligned with the existing outlet piping penetrating the dam. It was decided to fabricate a steel transition piece to marry the exiting piping with the new tower and gate. Because the work would be done in February when the reservoir would be at its lowest annual level, the decision to use inflatable bladder dams was made. The Contractor would need to clear snow and break ice to place the bladder dams, as well as, maintain streamflow diversion lines during extreme snow and subzero temperature conditions at all times.

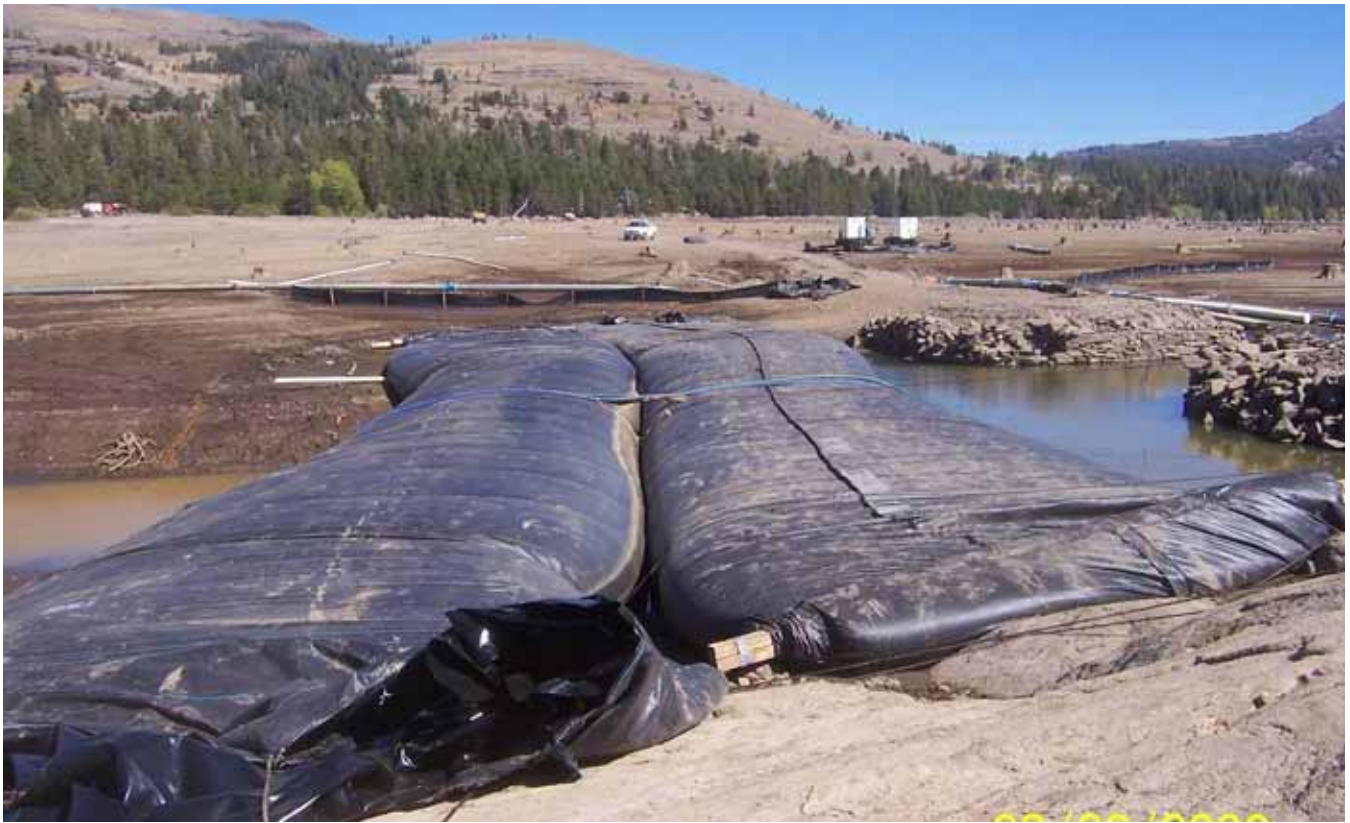
Figure 9. Bladder dams for the 2008 emergency repair of Caples Dam outlet

practicality to accomplish the work. Therefore, inflatable bladder dams were chosen to retain the reservoir during construction. A site within the reservoir was located by bathymetric survey where the bladder dams could be located; however, this would require a 3,200 ft long pumping line to maintain required minimum streamflow at all time during outlet gate replacement. Even the pump-around was challenging since the dam crest was also a roadway for CA Highway 88, a major road between the Central Valley and Lake Tahoe. Fortunately, a dual drainage culvert was located so that the diversion line would not interfere with traffic. Finally, access to the outlet wet well shaft would require a lane closure for duration of construction. The Contract elected to use a dewatered bench on the upstream slope of the dam as a work platform and staging area to limit road closures.

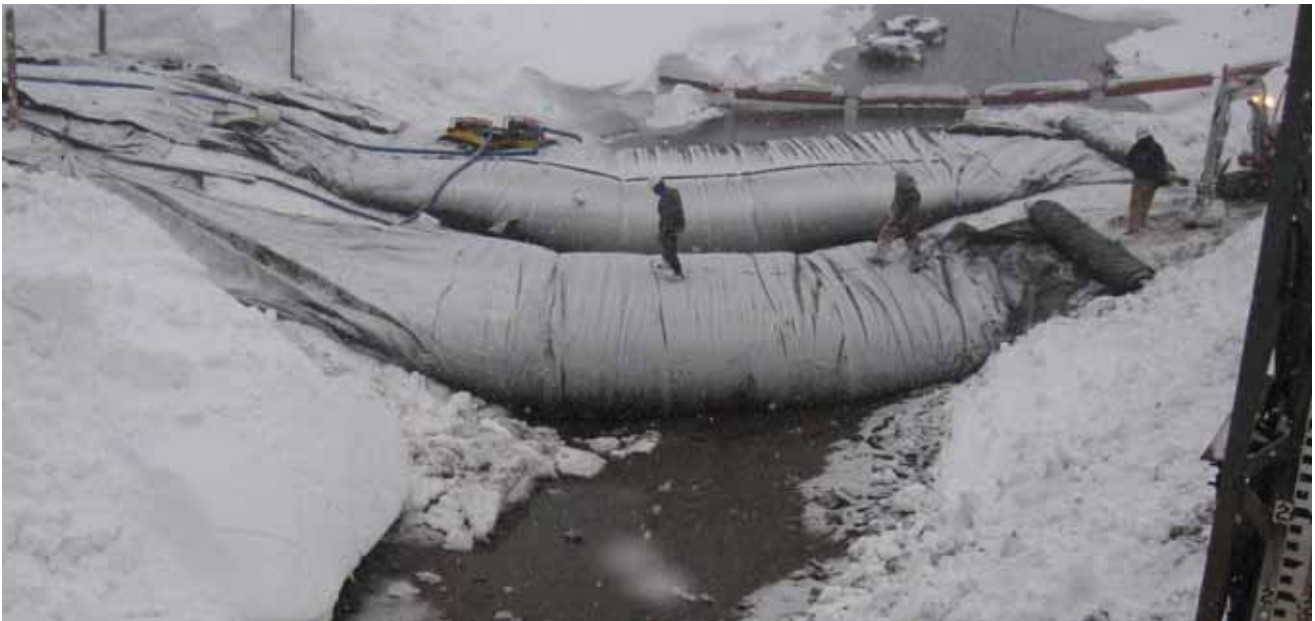
Figure 10. Bladder dams for the 2009 emergency repair of Silver Lake Dam

Silver Lake is annually drawn down as part of normal operations. The reservoir level during the annual low period is sufficiently low to install bladder dams to dewater the site. The only problem is that this annual low occurs generally in late winter and just prior to the spring run-off period. This meant that the most we could allot was between 3 and 6 weeks to get in and out of the reservoir bottom. Once the spring run-off was to begin, inflows to the reservoir would overwhelm the capacity of the bypass pumps and quickly overtop the bladder dams resulting in construction site evacuation and an incomplete construction. Another schedule option would have been to delay to the next fall; however, this would have meant being exposed to the risk of another season of dam operations with an unstable tower and another reservoir drawdown.

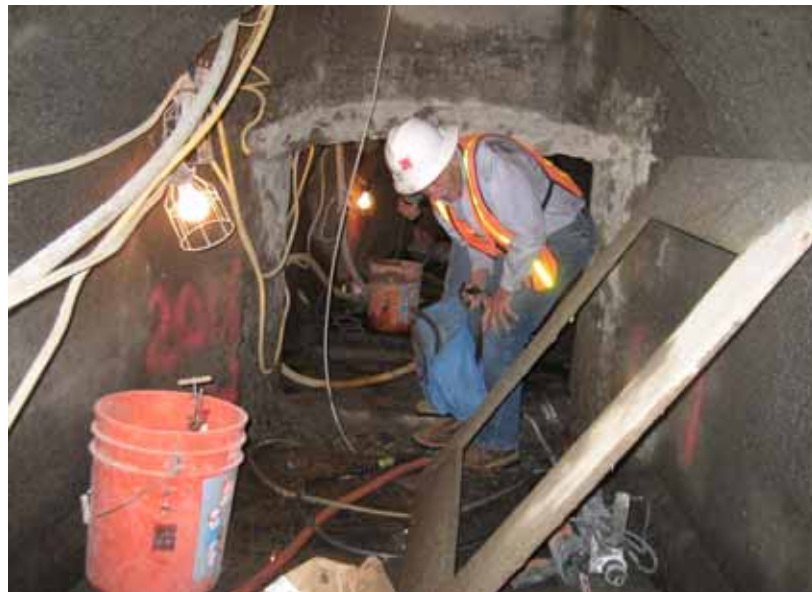
Figure 14. Enlarging concrete breast-wall for gate thimble.

The next significant issue faced was the selection and procurement of the gates. The original gates had cast-iron leaves with bronze seals. Replacement in-kind with cast iron gates was considered until it was learned that production schedules would be lengthy and would not fit the required construction schedule. After contacting a number of gate suppliers, the choice of fabricated stainless steel gates was the selected option. However, fitting up stainless steel gates into the existing openings in the concrete breast wall was uncertain. Therefore, the gates were ordered with stainless steel thimbles to assure proper fit and sealing. This requirement necessitated enlarging the gate openings in the concrete to fit the thimbles.

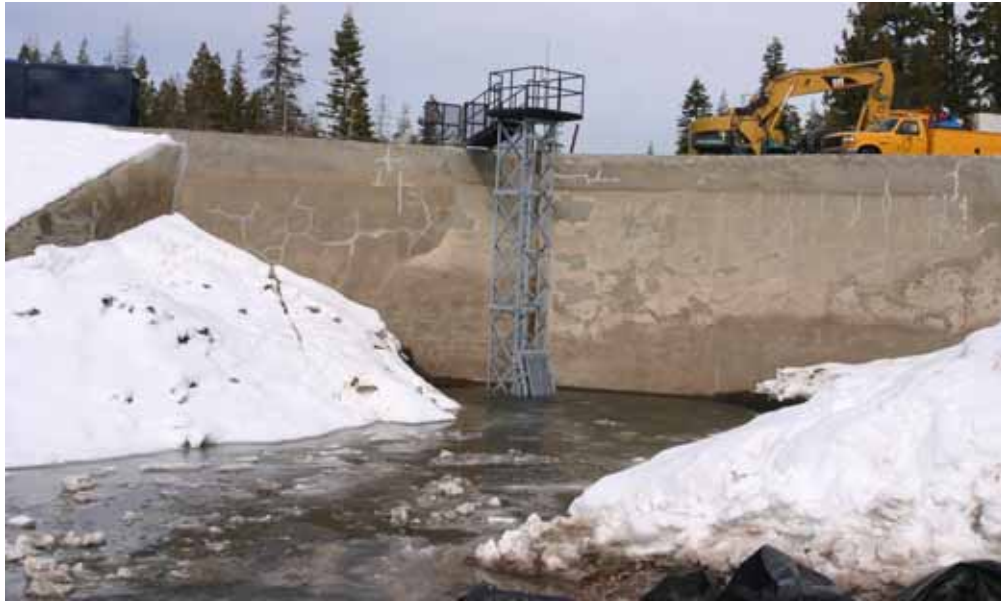
Figure 16. Completed Silver Lake emergency tower and gate replacement

The Silver Lake project implementation began immediately following the Caples Lake project in early November. The schedule called for engineering, gate procurement, permitting, and approval during November, December, and January to allow for construction in February. The same project delivery team repeated the process. GHI was again selected to provide the single gate, stem, stem guides, and operator. The gate was ordered in late December and delivered in early February, in spite of record snows in Washington that shut down the plant for a number of days. At the same time, the replacement tower was designed, and ordered before any approvals were obtained. The plan was to deliver the gate and its transition pipe to a metal fabricator in Nevada City, CA for fit up and alignment checks before trucking to the lake site. The contractor mobilized in early February and positioned the bladder dams, set the streamflow diversion system, and dewatered the site. Before any teardown, the tower foundation was cleared of debris and inspected. Contrary to the as-built drawings, the tower legs rested upon a relatively thin concrete mud-slab on rock. Fortunately, the design for the connection to the tower had anticipated varying conditions so “plan B” was initiated. The original tower was removed and 12-inch diameter piers were drilled into rock, and prefabricated stub angles imbedded. After concrete curing, the tower was elected to rest upon a new concrete slab bolted to the stub angles. Prior to setting the tower, the contractor erected a heated temporary shelter over the outlet pipe and transition area to allow for welding and concreting out of the weather. Once the tower foundation was ready and the pipe transition was welded and tested, the tower was erected as a single structure and the new gate fitted up. Then a short walkway was erected to connect the outlet tower to dam crest. Gate leakage was observed to be zero before returning the lake to outlet control.
