EMERGENCY OUTLET GATE REPLACEMENT PROJECTS AT TWO EL DORADO IRRIGATION DISTRICT HIGH SIERRA LAKES

William Rettberg, P.E. and Jacob E. Eymann, P.E.

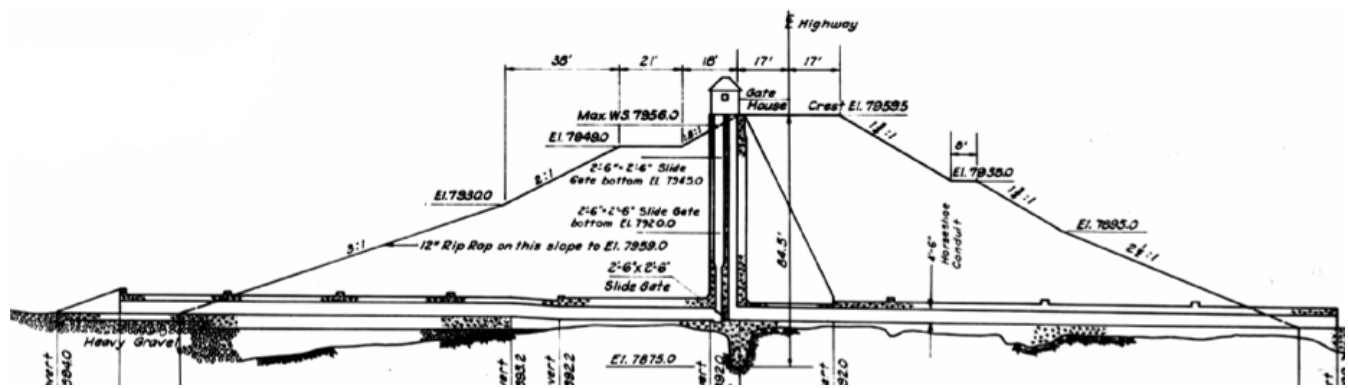
Figure 5. Caples Lake Main Dam cross-section showing gate house gate shaft, gate locations, and conveyance conduit.

- Bronze seats for the lower slide gate were missing, resulting in excessive leakage and vibration;
- The lifting connection of the lower slide gate leaf and the gate stem was degraded and loose;
- The concrete adjacent to the lower slide gate frame was heavily eroded, resulting in steel reinforcement exposure and corrosion;
- The lower gate stem was bent in two directions, which resulted in binding against the concrete shaft wall and the upper gate during gate operation;
- Several metal stem restraints required to align, guide, and prevent stem buckling were missing or broken;

- The slide gates, gate stems, and stem guides were all severely corroded, compromising their structural integrity and putting them at risk of sudden failure;
- Both gate stems were found to be installed out of plumb;
- Combined leakage from the closed slide gates was approximately 900 gallons per minute and
- The trash rack on the intake was severely bent and dislodged from its original installation.

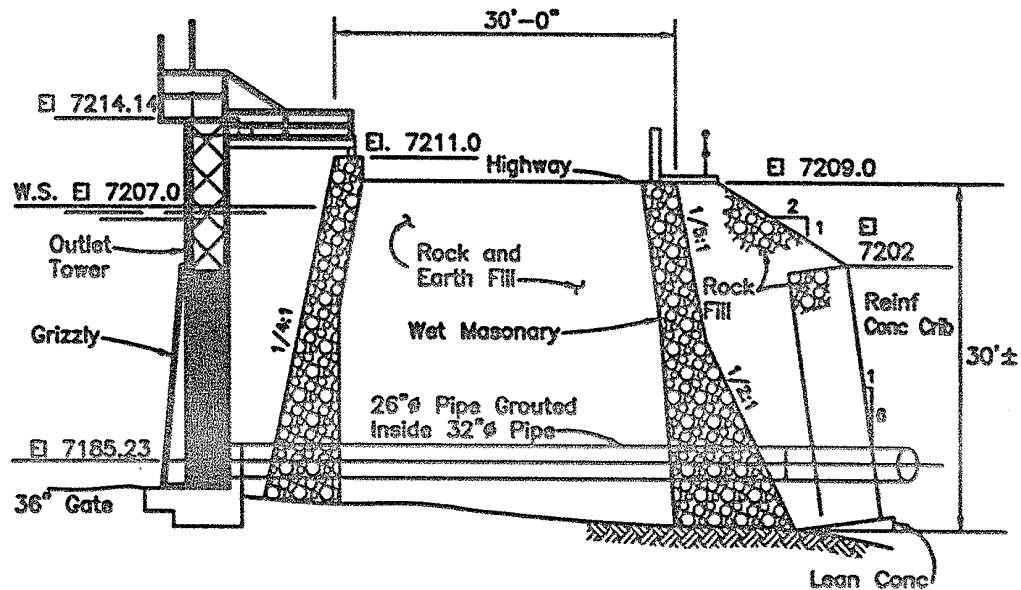
Figure 6. Silver Lake Dam cross-section showing outlet tower and gate location.

- The steel bracing for the outlet tower was completely failed due to corrosion;
- The other steel members had experienced significant corrosion and section loss;
- The degree of corrosion increased from top to bottom on the outlet tower;
- The valve stem was heavily corroded and pitted.

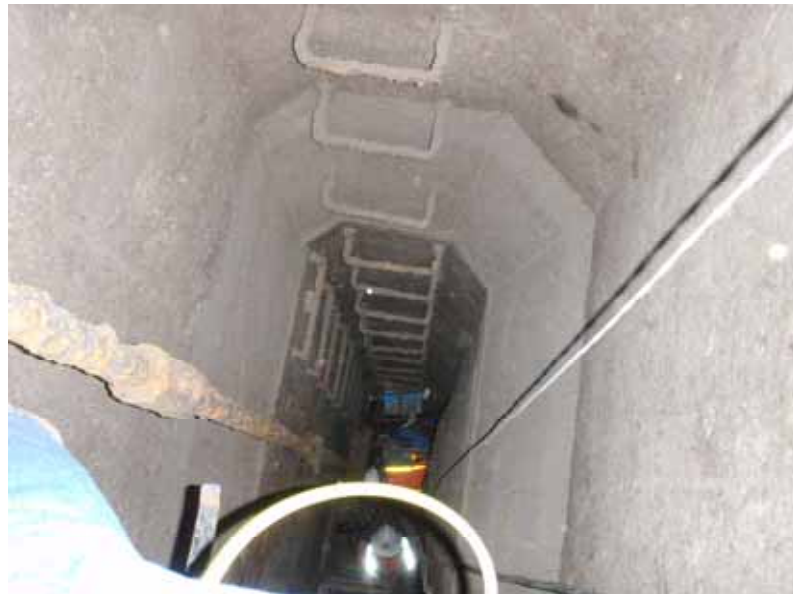
Figure 13. Working within 68 ft. deep, tapering, cramped gate wet well shaft.

alignment of the gate thimbles, gates, and stems were critical to project success. At the same time, the existing gate openings in the breast wall were being enlarged, the outlet conduit was inspected. Concrete cores were obtained in the invert which confirmed that while most of the conduit was on rock, the upstream and downstream ends were on gravels. Once the gate thimbles were properly aligned, concrete backfill and grouting was done to assure intimate connection to the concrete breast wall. Following concrete curing, the gate stems were set and aligned, and manual operators set in the control building. After a final inspection, a new trashrack was set in the intake and the bladder dams removed returning lake control to the lower gate. The lower gate was inspected to confirm it was properly sealed before the gate was operated to make the required streamflow releases before the diversion pumps were shut off and the piping removed. As the project was being completed in late October, the temperature began to fall and snow followed.

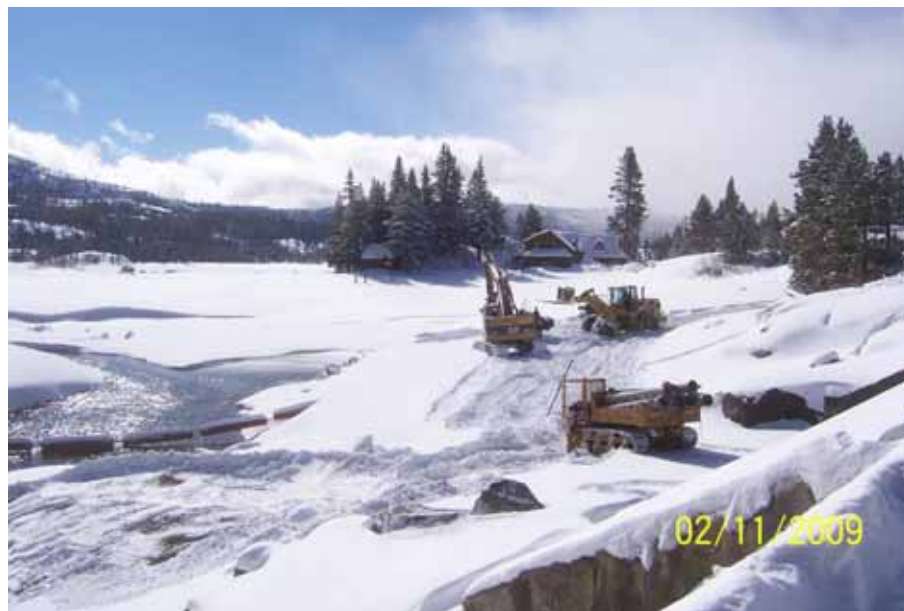
Figure 15. Construction site during 2009 emergency repair of Silver during good weather

The Silver Lake project implementation began immediately following the Caples Lake project in early November. The schedule called for engineering, gate procurement, permitting, and approval during November, December, and January to allow for construction in February. The same project delivery team repeated the process. GHI was again selected to provide the single gate, stem, stem guides, and operator. The gate was ordered in late December and delivered in early February, in spite of record snows in Washington that shut down the plant for a number of days. At the same time, the replacement tower was designed, and ordered before any approvals were obtained. The plan was to deliver the gate and its transition pipe to a metal fabricator in Nevada City, CA for fit up and alignment checks before trucking to the lake site. The contractor mobilized in early February and positioned the bladder dams, set the streamflow diversion system, and dewatered the site. Before any teardown, the tower foundation was cleared of debris and inspected. Contrary to the as-built drawings, the tower legs rested upon a relatively thin concrete mud-slab on rock. Fortunately, the design for the connection to the tower had anticipated varying conditions so “plan B” was initiated. The original tower was removed and 12-inch diameter piers were drilled into rock, and prefabricated stub angles imbedded. After concrete curing, the tower was elected to rest upon a new concrete slab bolted to the stub angles. Prior to setting the tower, the contractor erected a heated temporary shelter over the outlet pipe and transition area to allow for welding and concreting out of the weather. Once the tower foundation was ready and the pipe transition was welded and tested, the tower was erected as a single structure and the new gate fitted up. Then a short walkway was erected to connect the outlet tower to dam crest. Gate leakage was observed to be zero before returning the lake to outlet control.
